BAD090
White finish

BAI090
White finish

General description

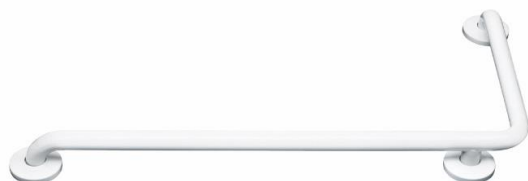
- White epoxy-coated grab bars curved in 90°, to be installed on the wall, with Polypropylene snap flanges and made of Ø 32 mm steel tube.
- These grab bars make the daily life-management of not only the disabled and elderly people easier but also it is a great support for everybody who needs help with moving.
- Especially designed to achieve barrier-free accessibility in bathrooms and public spaces.
- With three snap flanges, made of white Polypropylene that provide a clean finished look hiding the mounting screws.
- Easy to clean.
- Optionally, they have a kit to avoid electrical conductivity (code KA0010).
- Fixing screws for brick wall included.
